This is the Biltmore home of the Vanderbilt family which is located outside Asheville, North Carolina. The structure is made from stone blocks and it has several basement layers. It took over 6 years to build this massive structure.

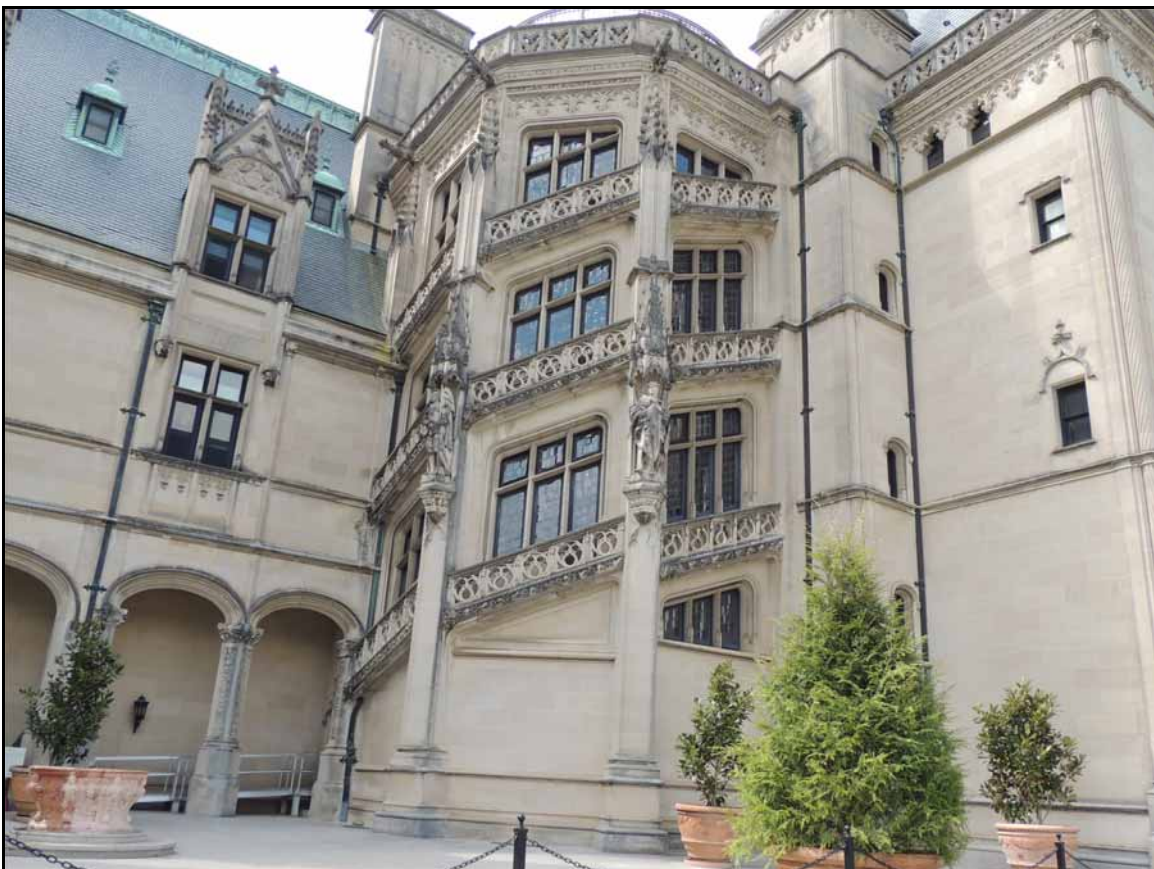
There are a lot of carvings in the stone. Note how the mold and grime is on the tops and bottoms of the carvings.

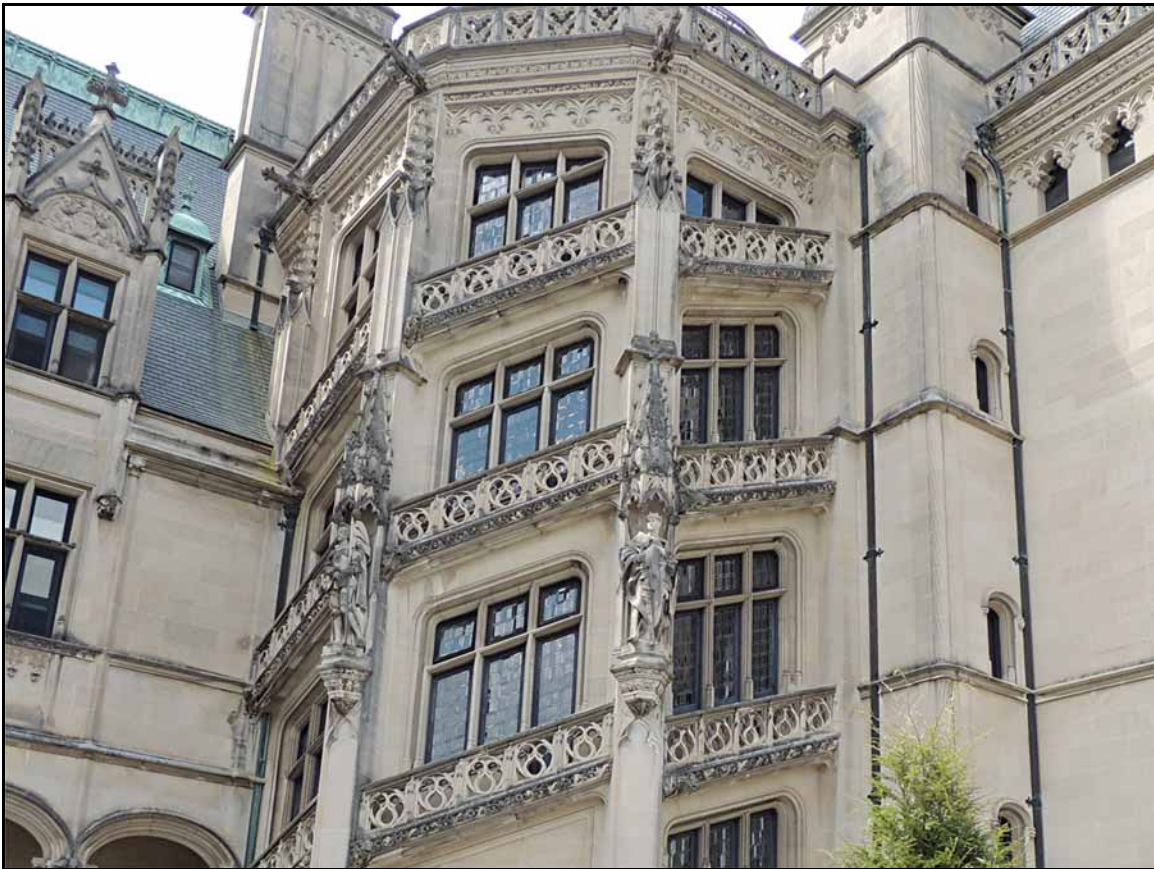
A close up of the stone carvings and statues show how much craftsmanship went into their creation. Note the color of the metal rain downspouts. The mold and grime is on the undersides of the stone carvings.

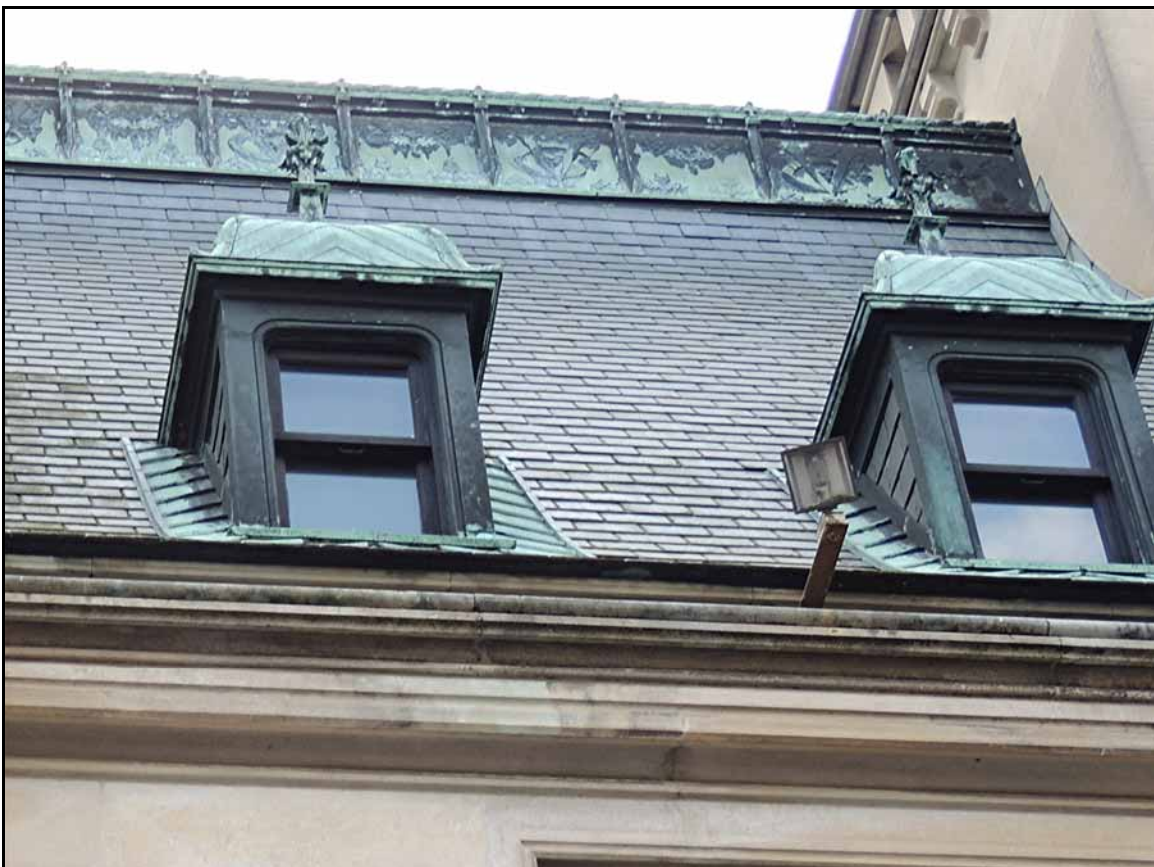
The metal sheeting, which is most likely thick brass, turns two different colors.

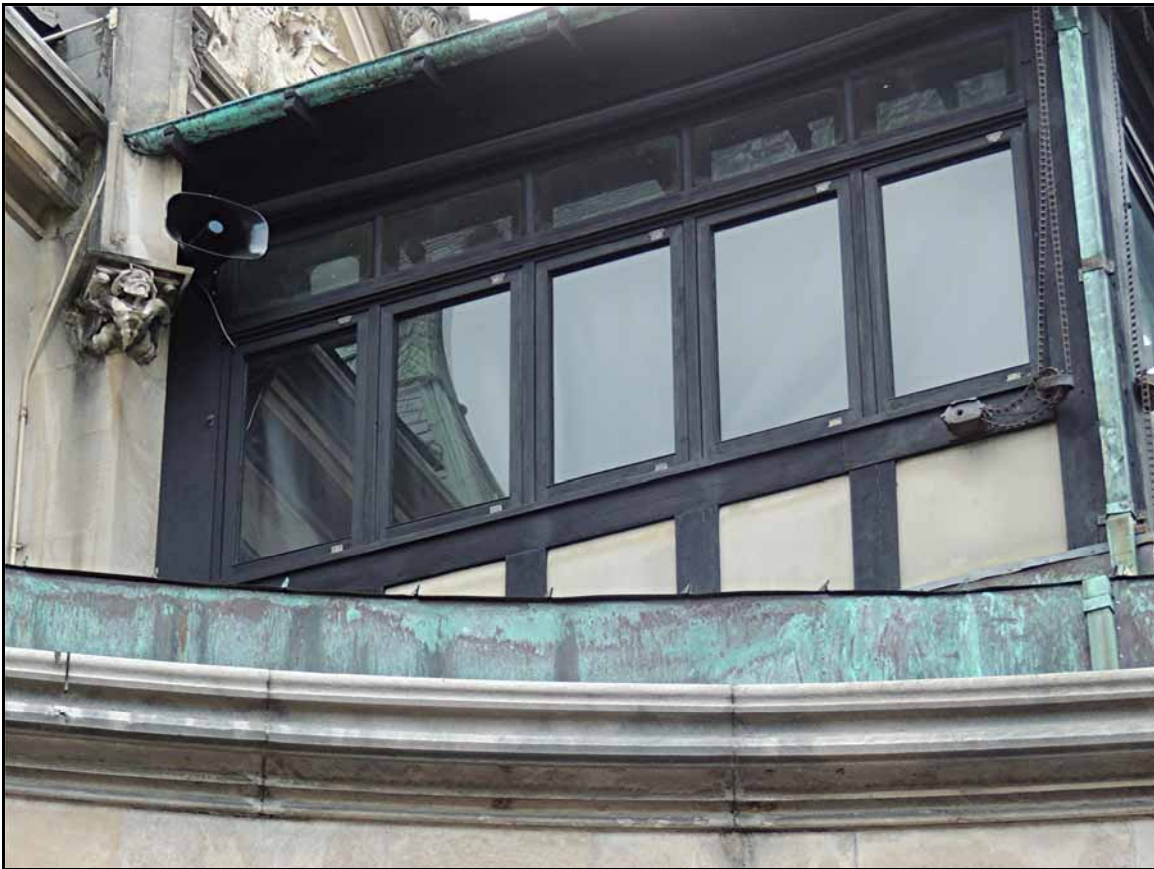
The metal used for the window framing has no iron in it which is why it is not showing signs of any rust. My guess is that it is also solid brass or a mixture of metal alloys with brass in it. Note the green color on the face of the brass sheeting have several different shades and is not consistent in color.

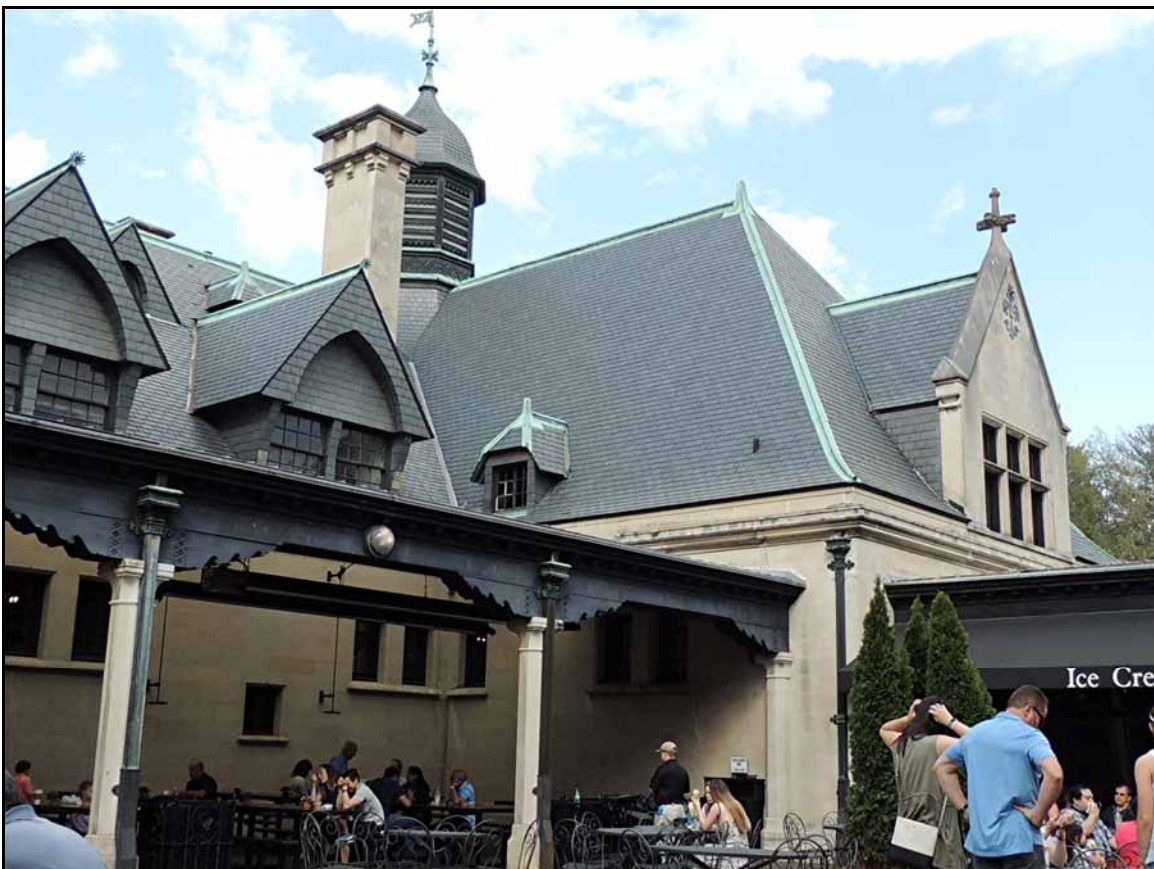
The brass sheeting caps on the roof peeks get a lot of sun which helps keep the green color the same shade. The color is a light green-lime flat shade.
